BOSTON
CHARLESTOWN NAVY YARD
THE RAILROAD TRACKS

HISTORIC STRUCTURE REPORT
Architectural Data Section

THE RAILROAD TRACKS
CHARLESTOWN NAVY YARD
BOSTON NATIONAL HISTORICAL PARK
Charlestown, Massachusetts

**REPORT OF SELECTED ALTERNATIVES
INVESTIGATION AND EVALUATION
OF
RAILROAD TRACK**

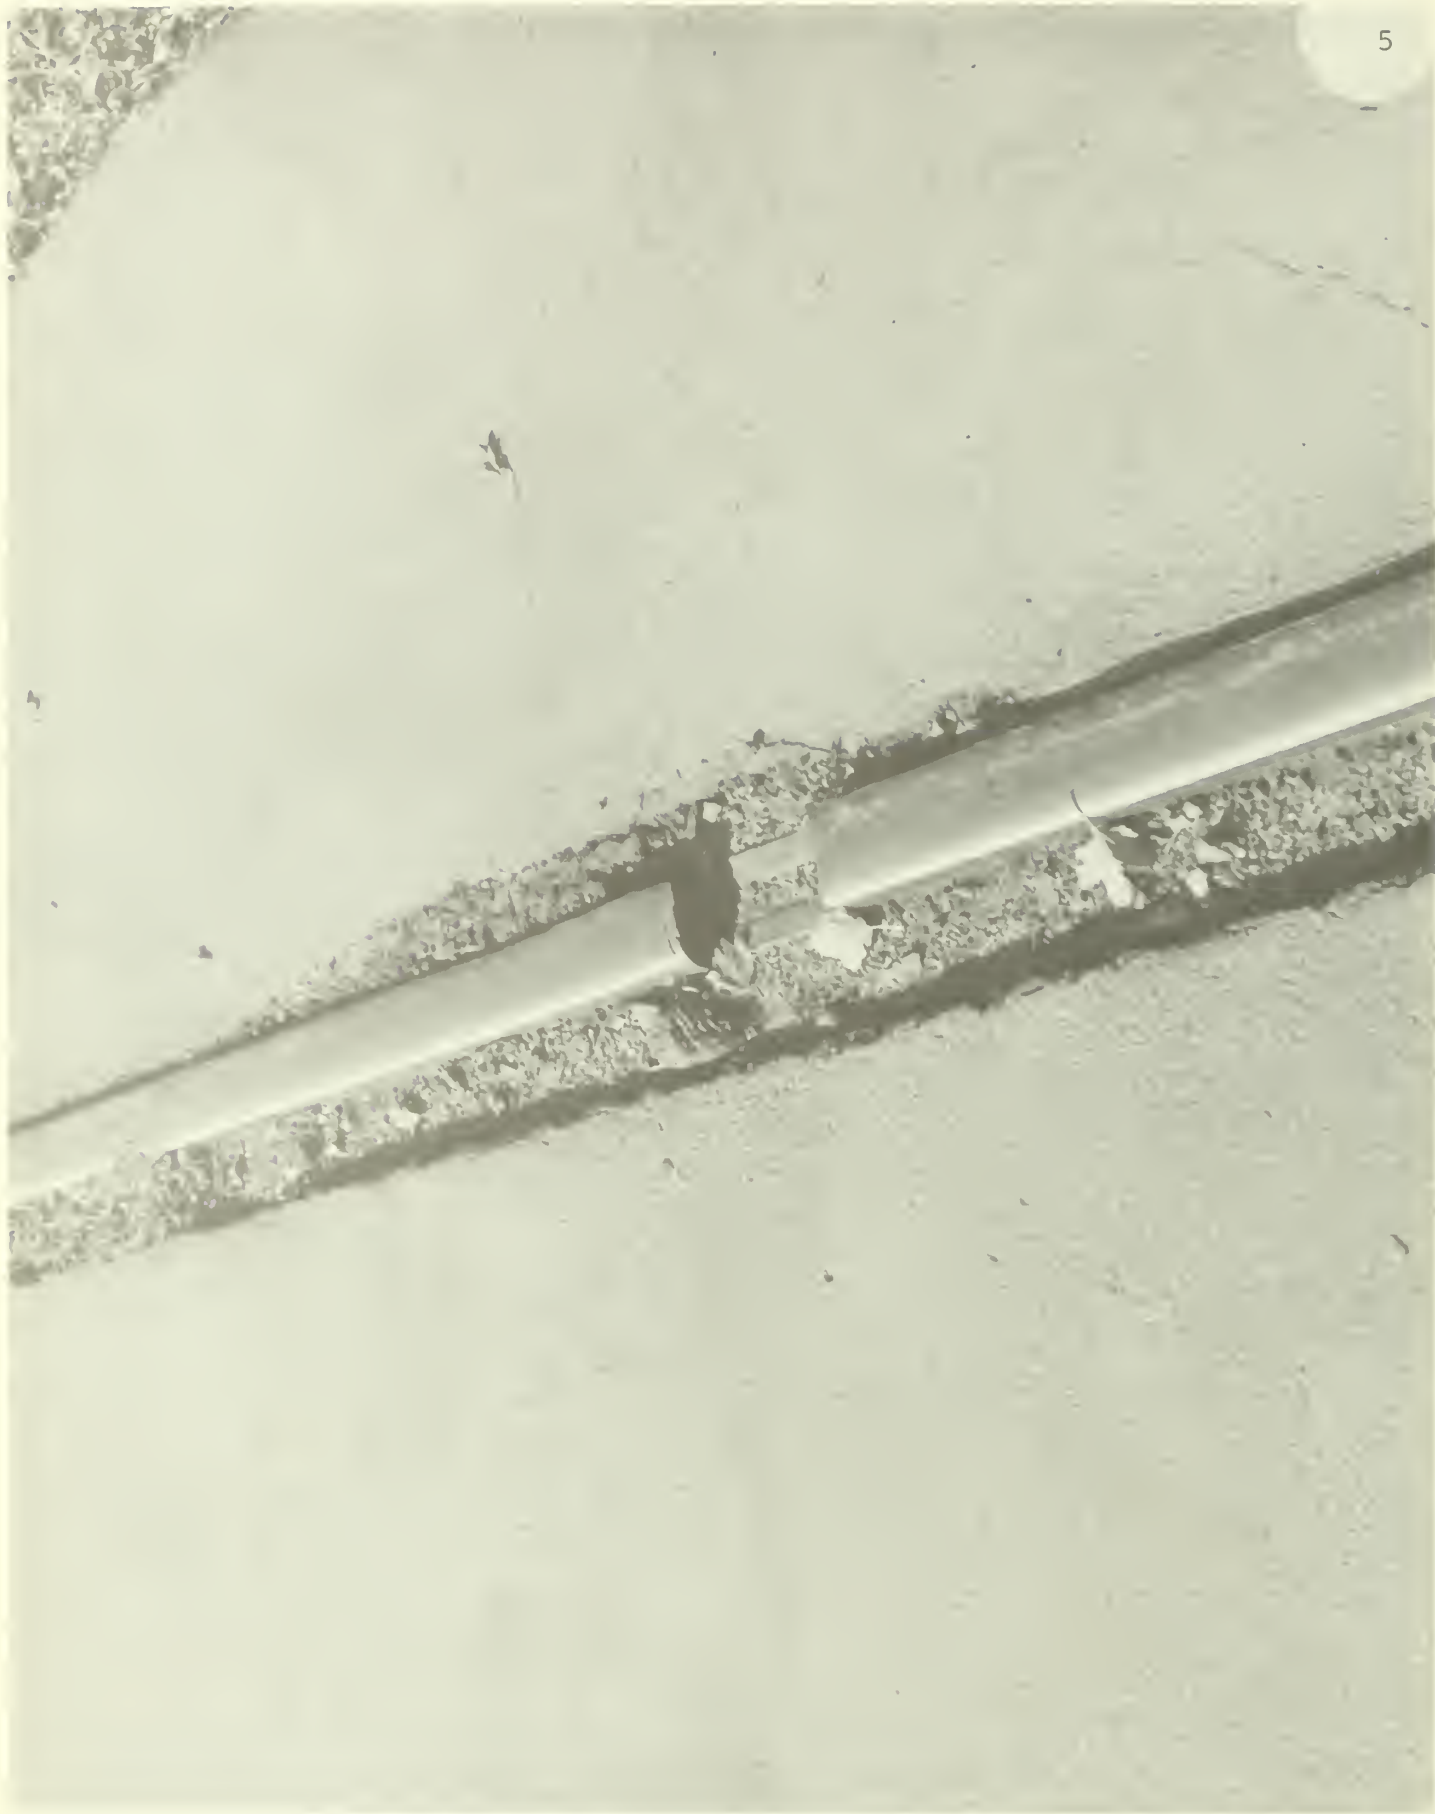
| <u>Photo No.</u> | <u>Location</u> | <u>Description</u> |
|---|---|---|
| 5 | Sta 7+05, Track 3 | Looking west where 6" segment of Track is broken out. |

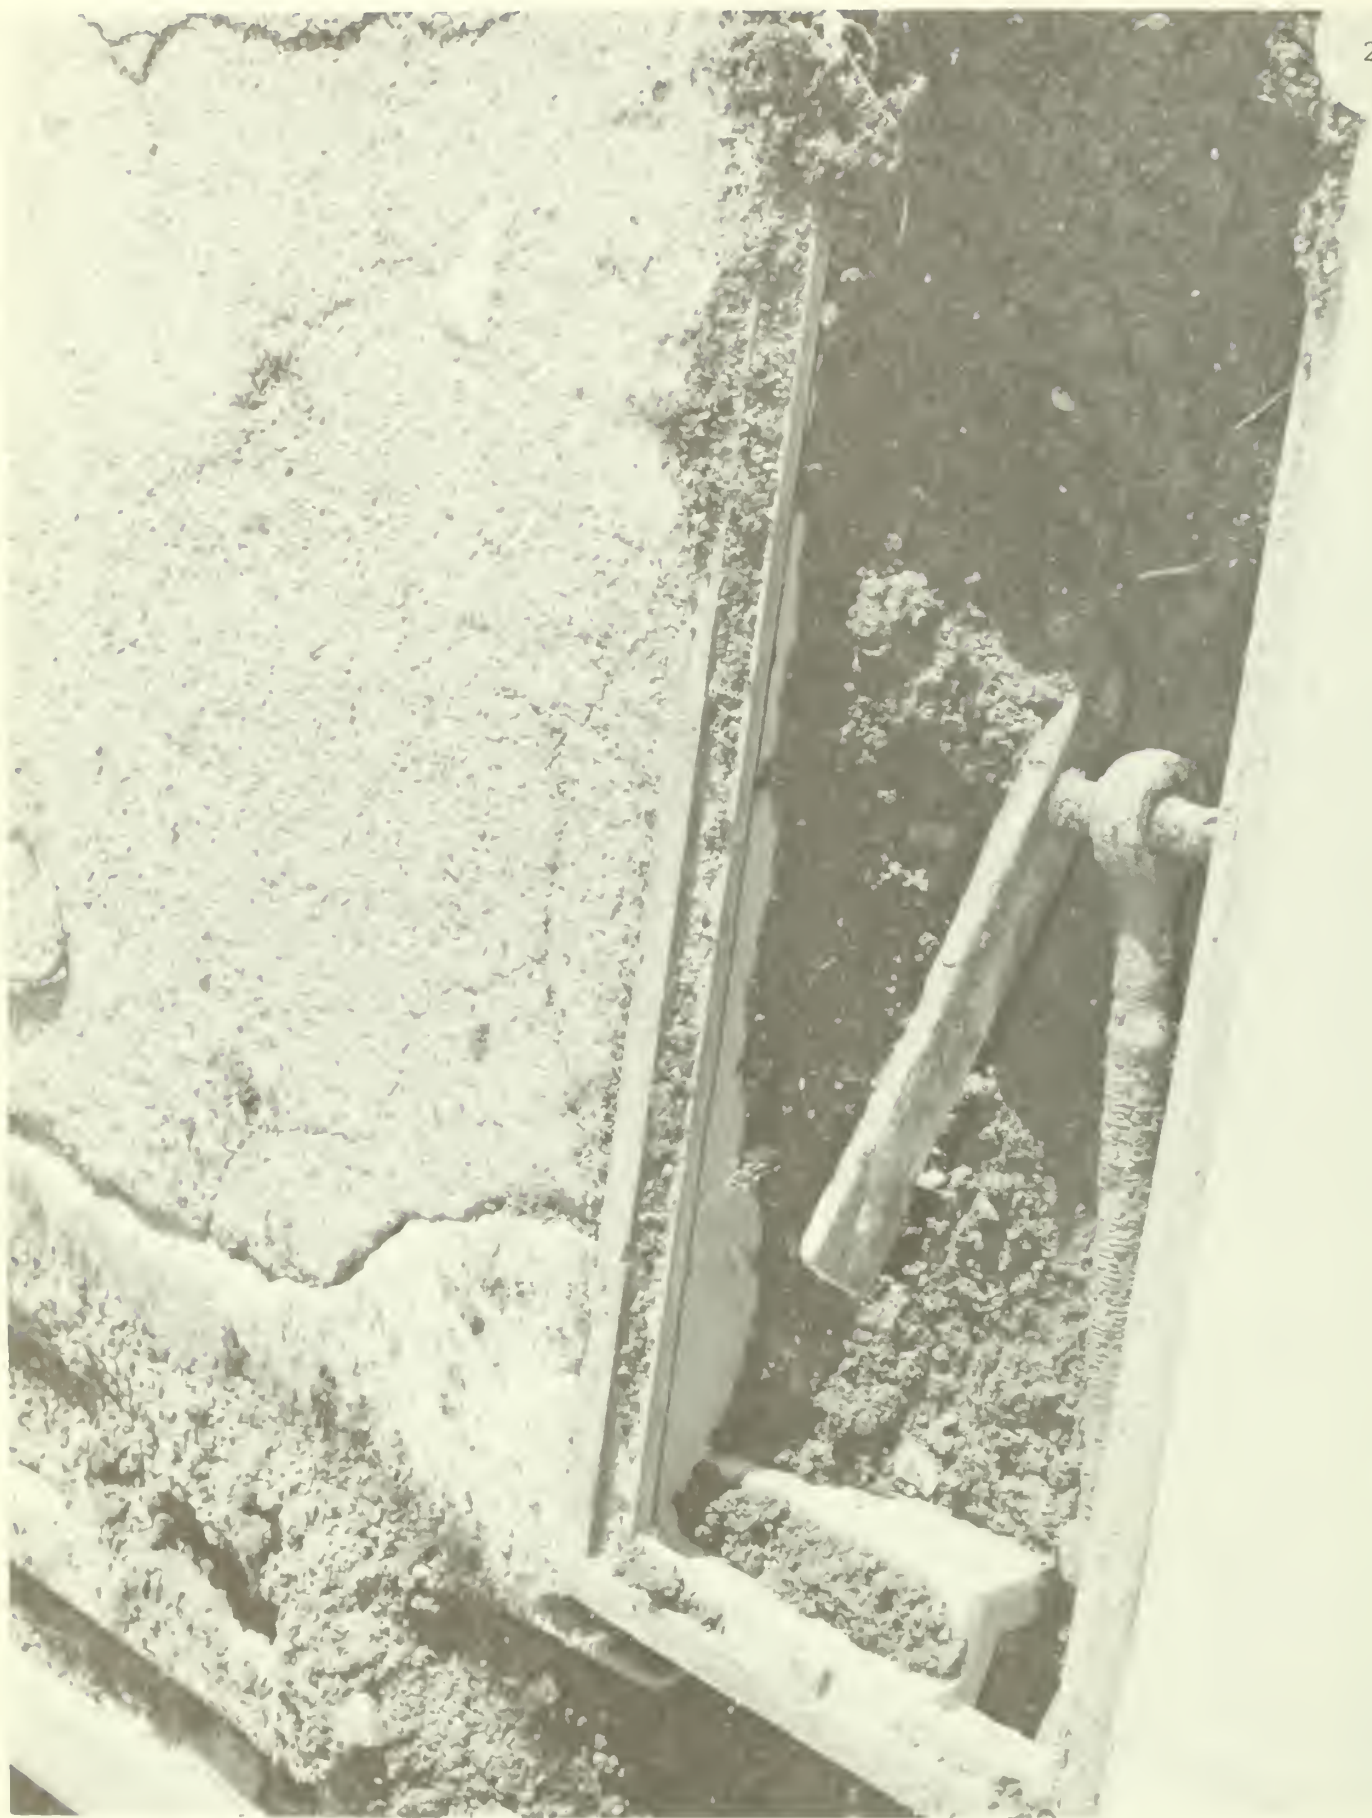
| <u>Photo No.</u> | <u>Location</u> | <u>Description</u> |
|---|---|---|
| 25 | Sta 5+86, Track 7 | Corroded Switch I for Track 7 and Crane Track |

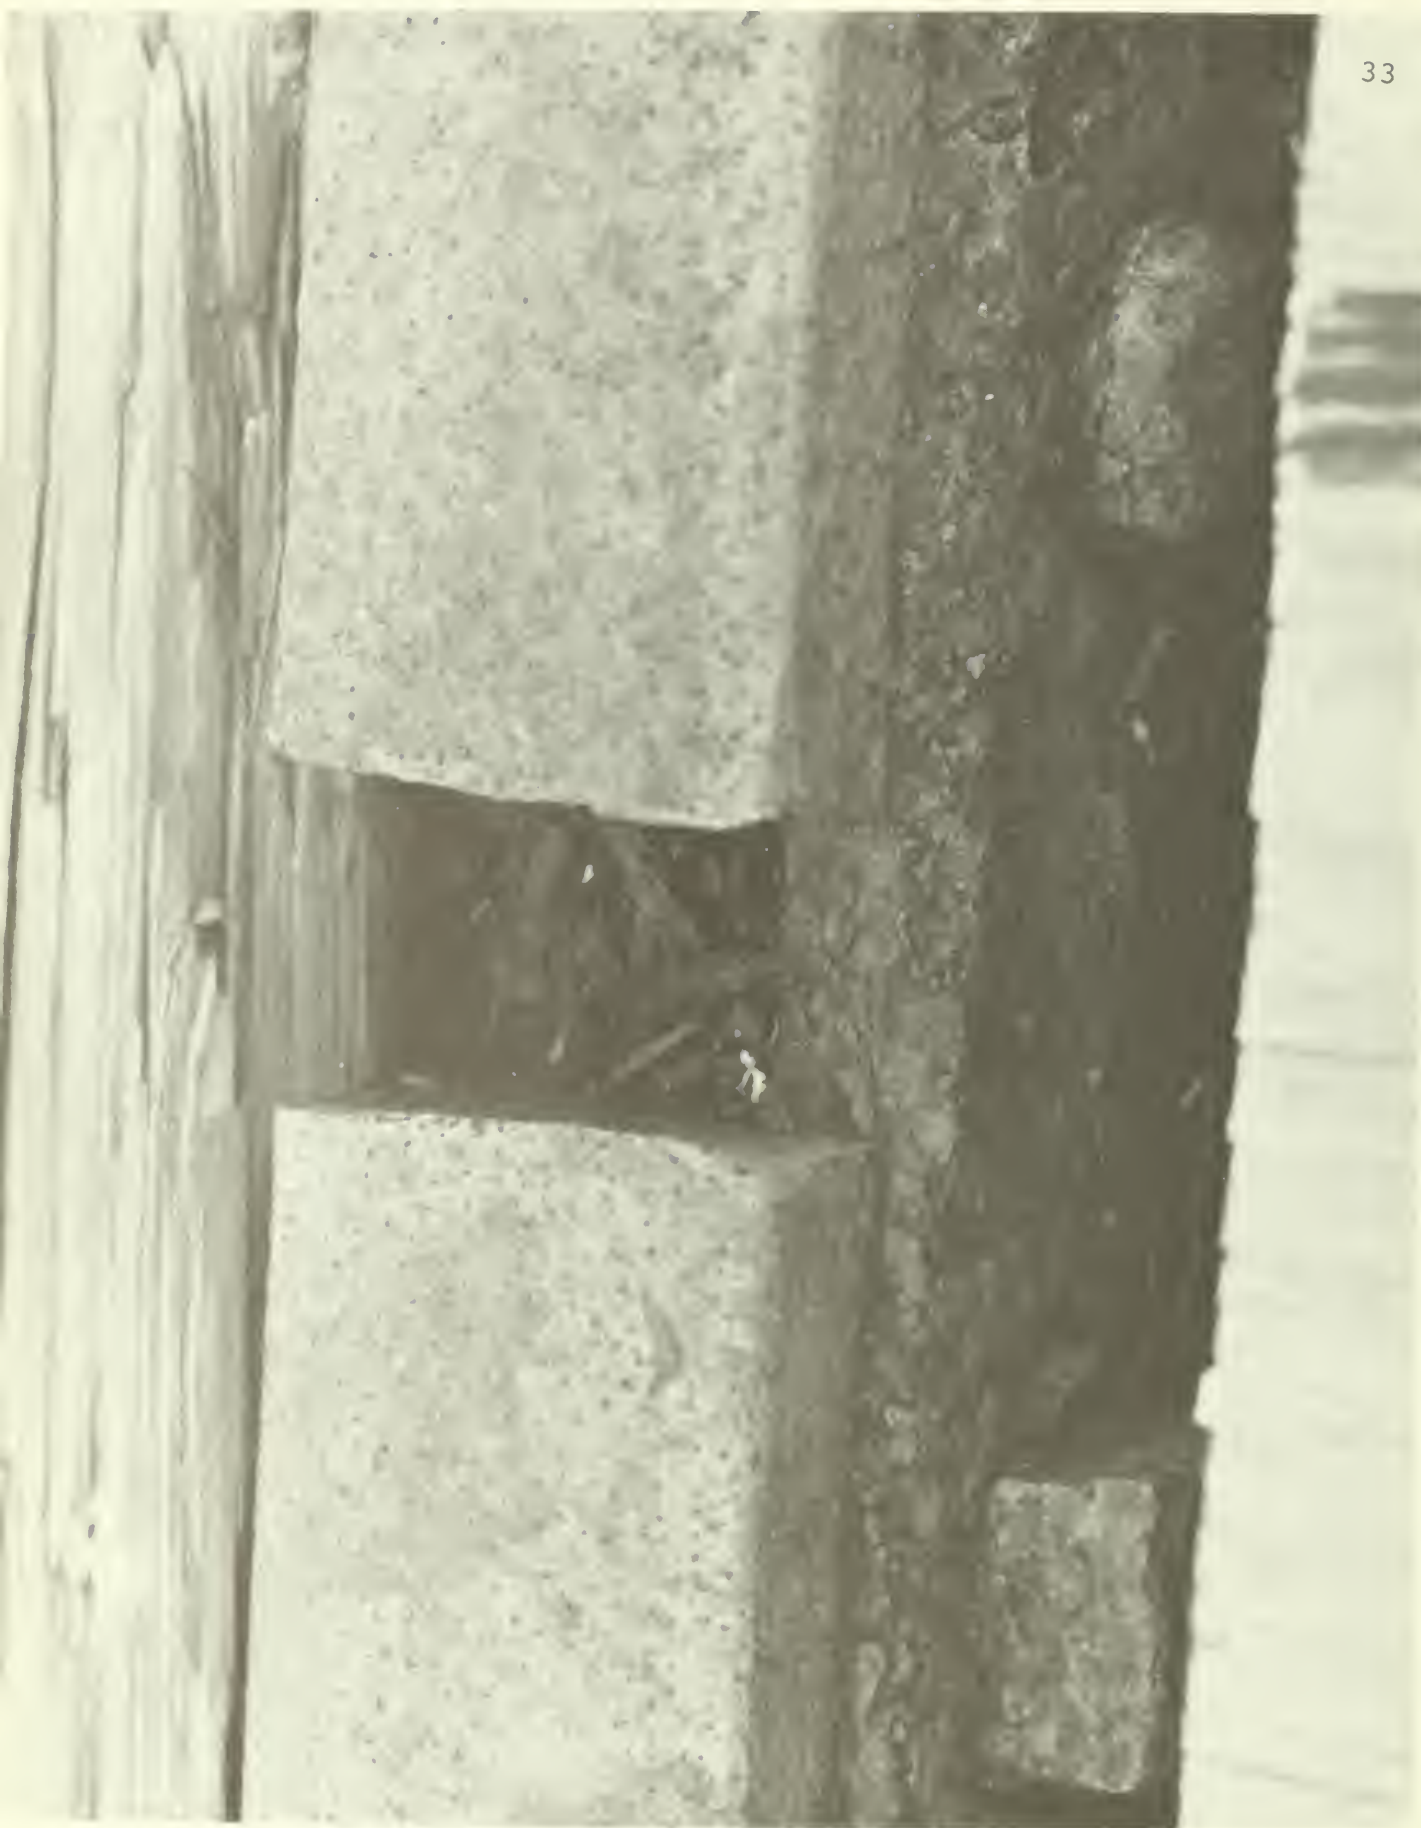
| <u>Photo No.</u> | <u>Location</u> | <u>Description</u> |
|---|---|---|
| 33 | Sta 1+45, Track 10 | 1½" gap in east rail and corroded track connection underneath. |

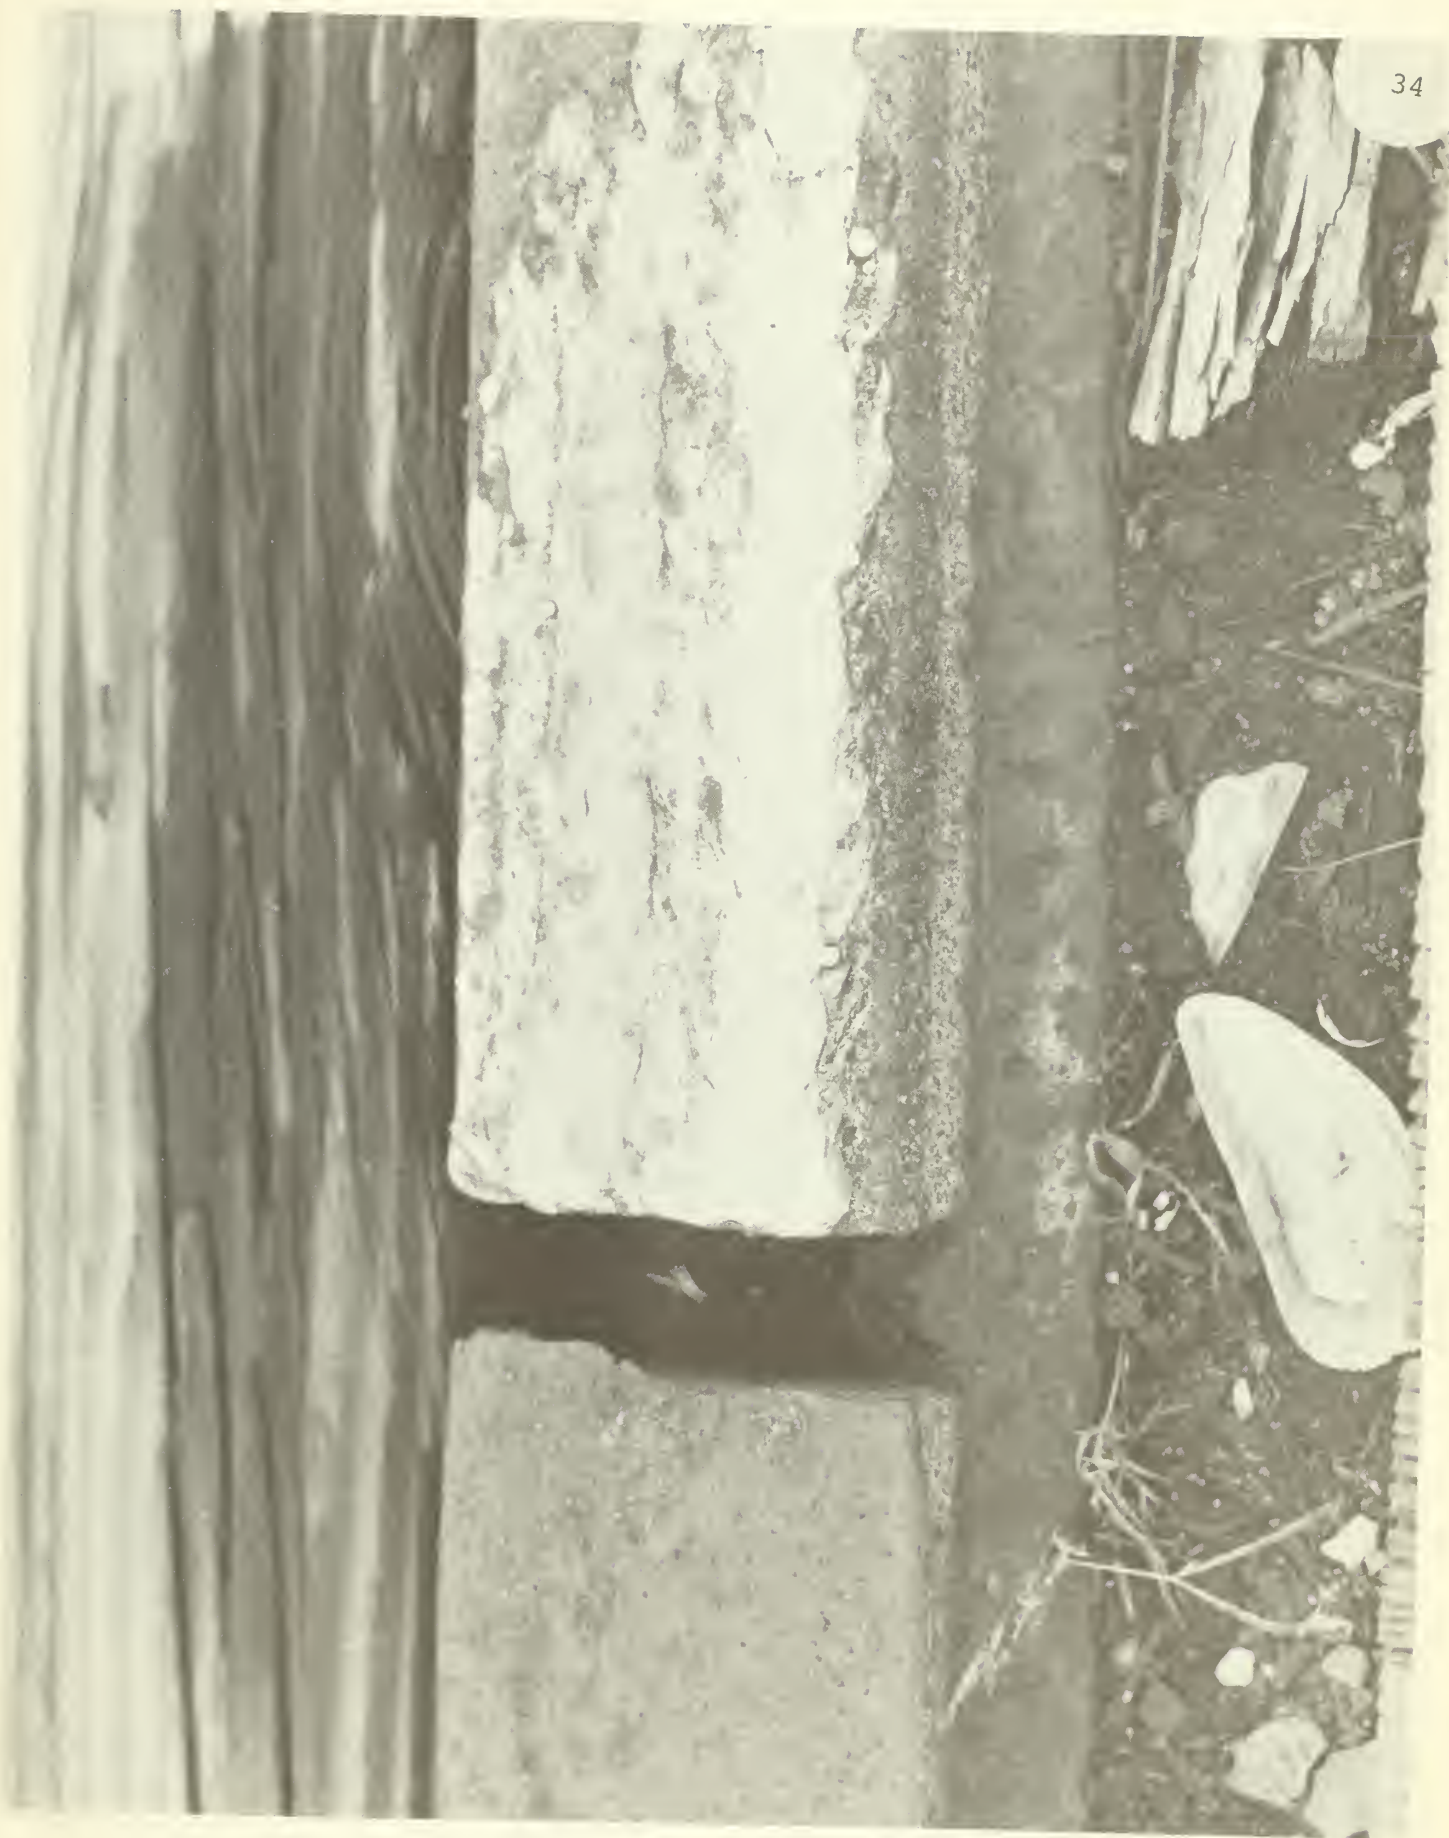
| <u>Photo No.</u> | <u>Location</u> | <u>Description</u> |
|---|---|---|
| 34 | Track 7 | Example of rail repair: rail on right of gap built up with welding. |

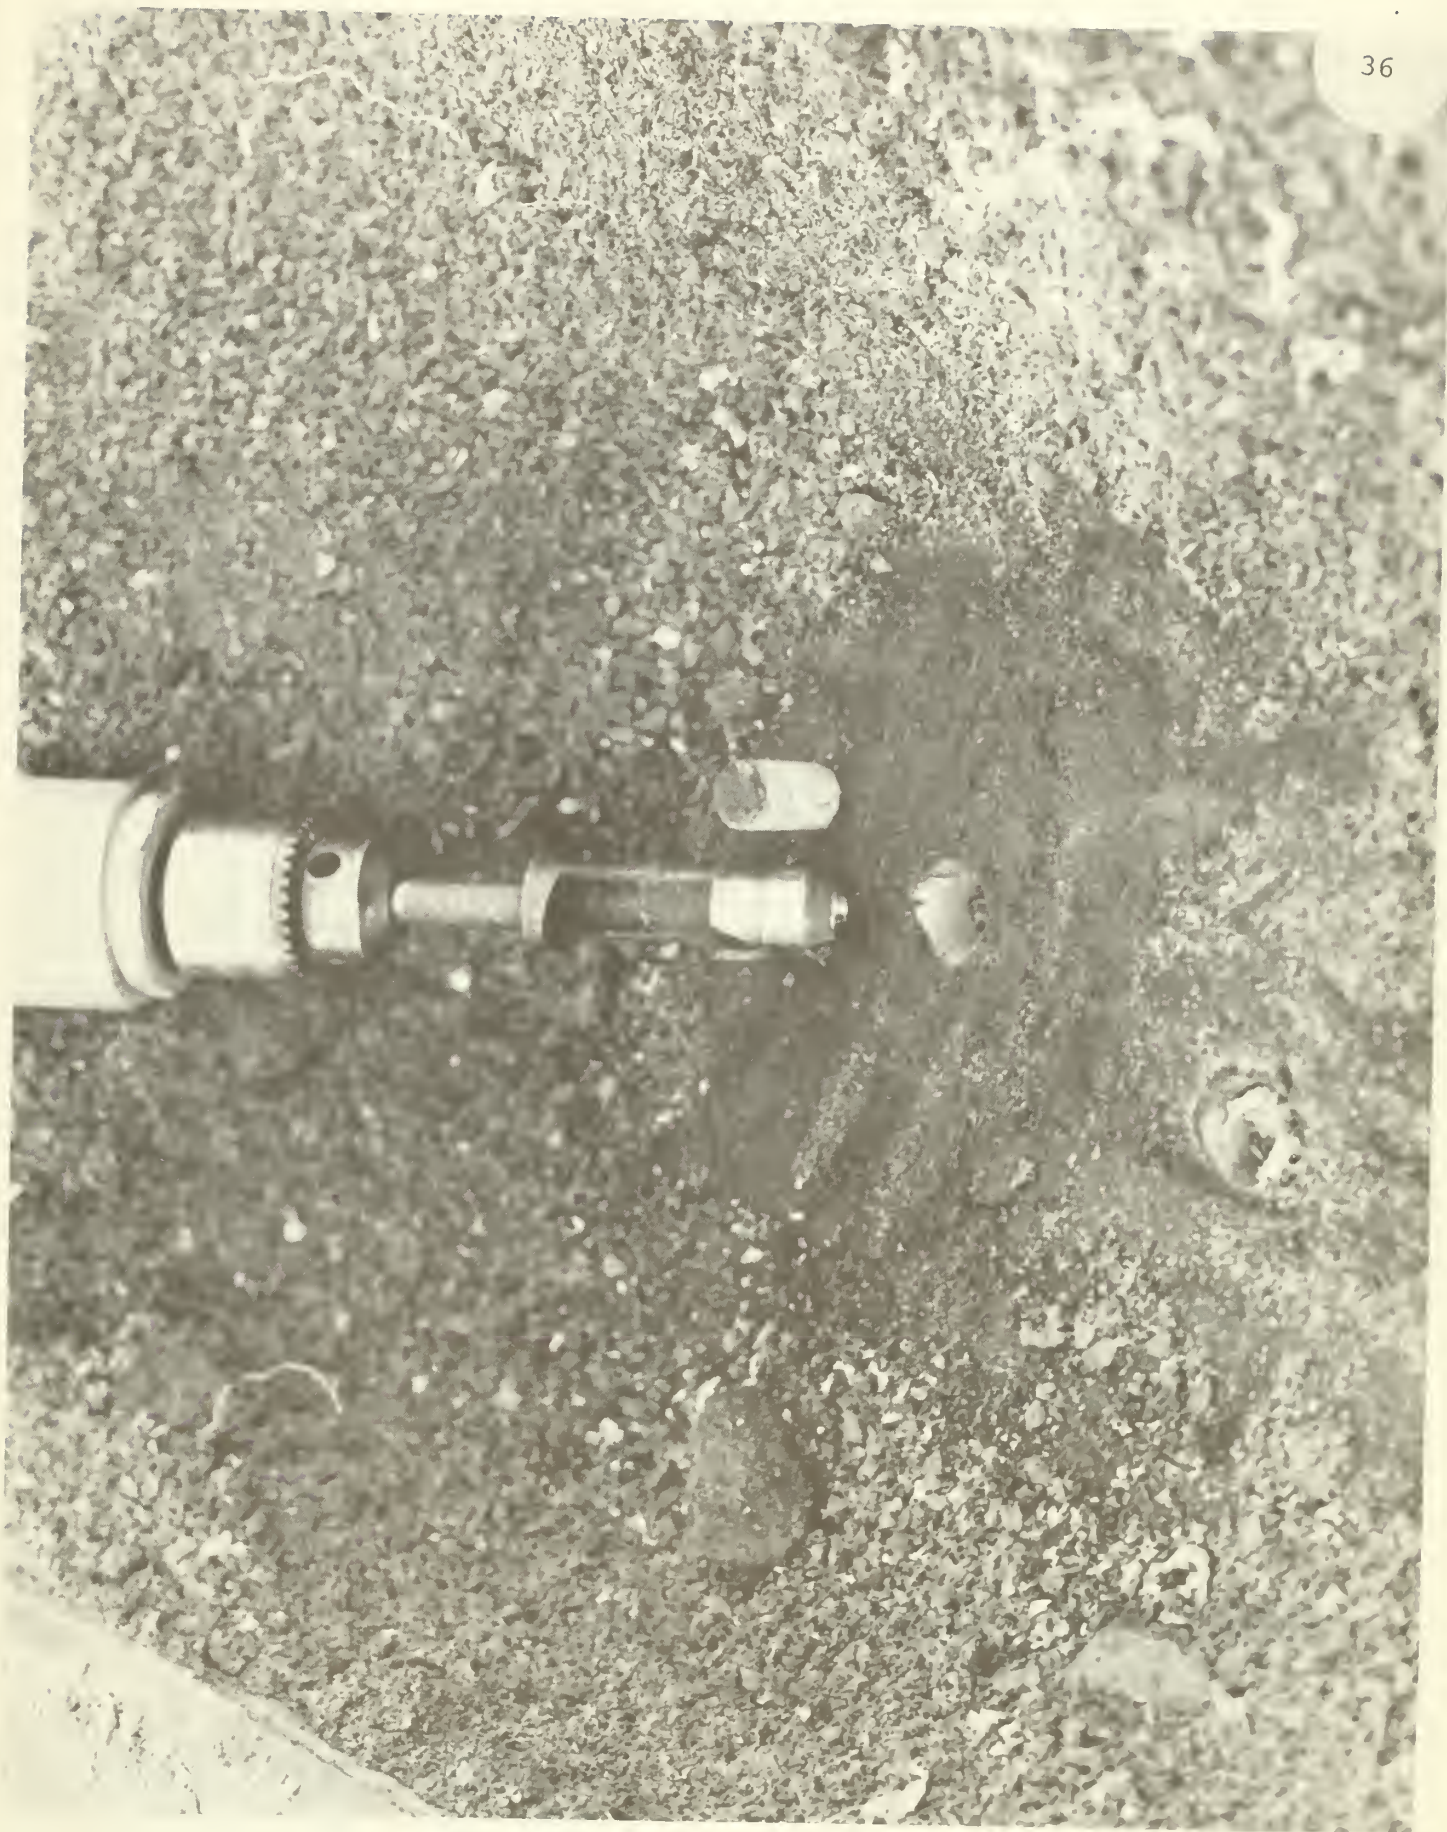
Core samples were taken in several areas to aid in determining crosstie conditions and to determine the degree of treatment of the ties. The extent of treatment of individual ties cored varied but generally found to be 1½ inches although one tie was found to have only surficial treatment and no penetration of preservative. The type of treatment was found to be creosote in all the ties sampled. In some of the ties which were tested moisture was found to have penetrated one to two inches.

| <u>Photo No.</u> | <u>Location</u> | <u>Description</u> |
|---|---|---|
| 36 | Sta 2+70, Track 6 | Coring bit and core from tie, used to check penetration of preservative. |
